Docket No. 217 – Development and Management Plan Inspection

Northeast Utilities Service Company Certificate of Environmental Compatibility and Public Need for the construction of a 345-kV electric transmission line and reconstruction of an existing 115-kV electric transmission line between Connecticut Light and Power Company's Plumtree Substation in Bethel, through the towns of Redding, Weston, and Wilton, and to the Norwalk Substation in Norwalk, Connecticut.

Date: January 19, 2006

Location: Overhead Line (Composite 345kV and 115kV Gallows Hill to Archers Lane) and (345kV H-Frame Hoyts Hill to Gallows Hill)

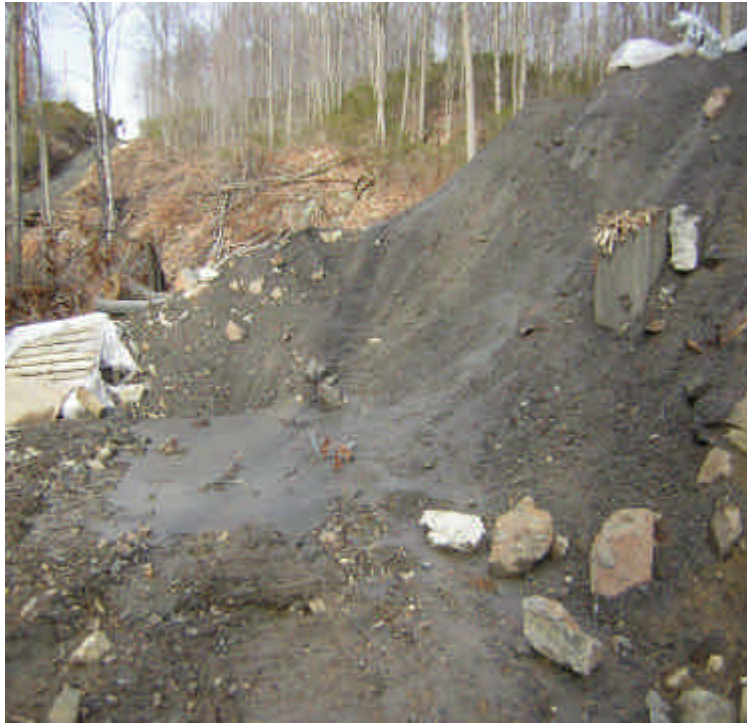
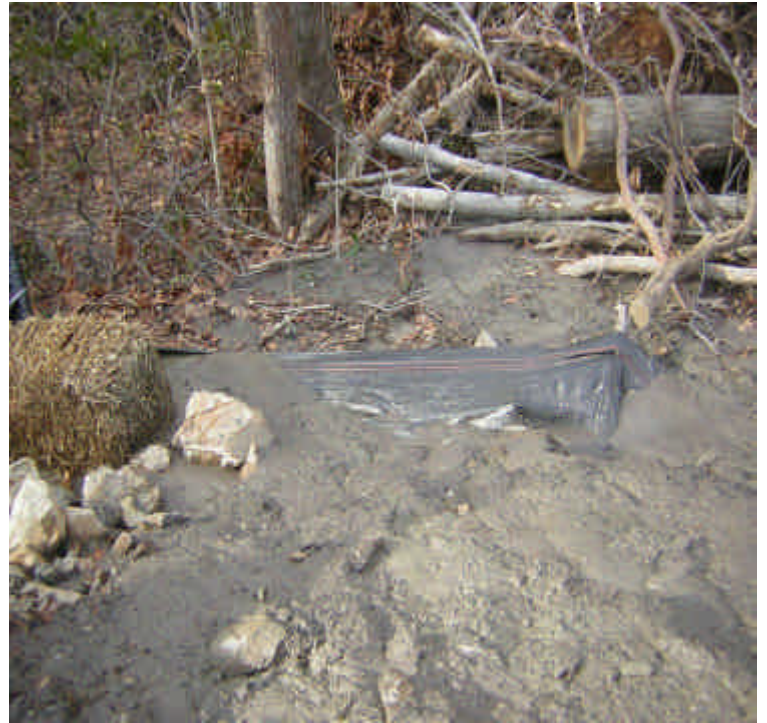
(Composite Section): Photo on the left shows a view of the sediment resulting from the installation of the structure adjacent to transition station. Photo on the right demonstrates how the sediment has pushed over the erosion controls. This needs repair as sediment is moving towards the wetland pocket downgradient. 1/19/06

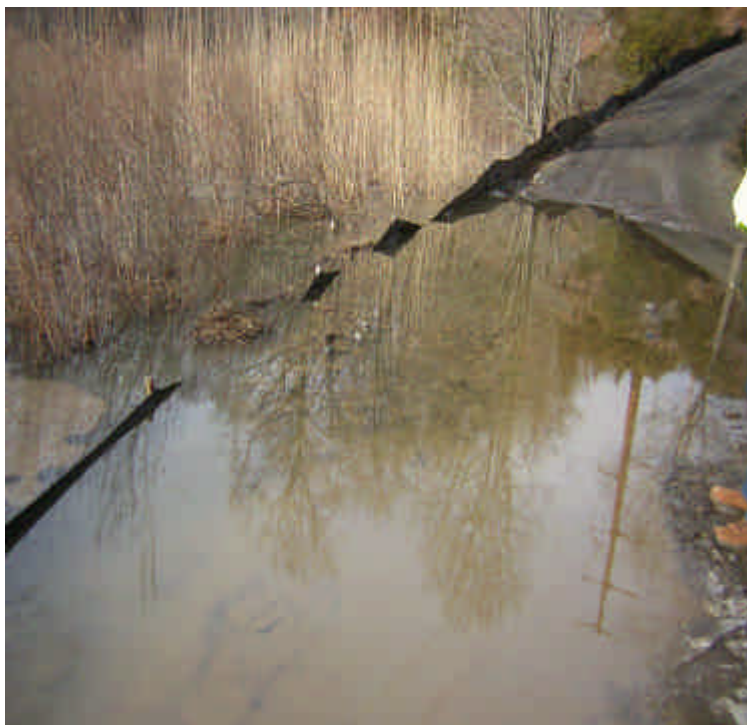
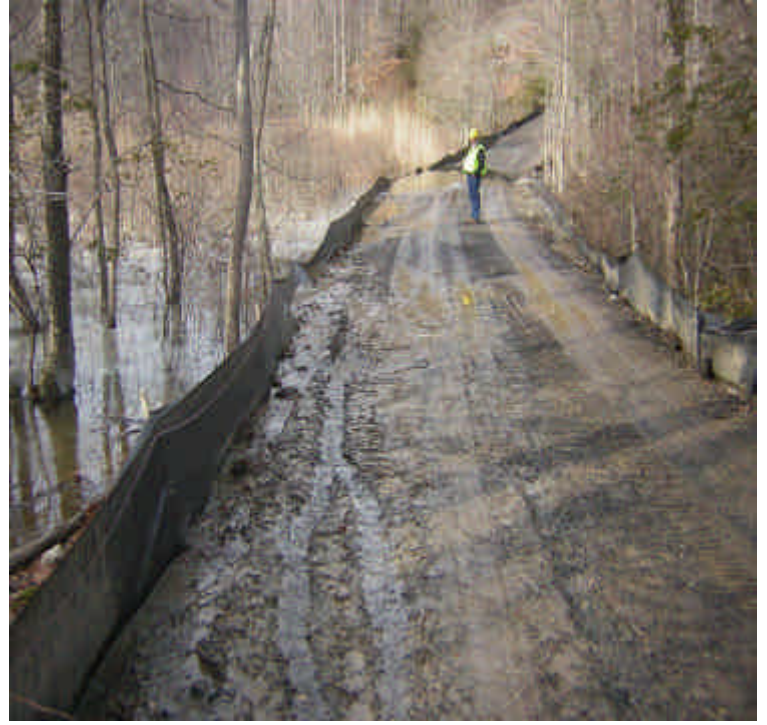
Photo on the left shows the 2nd wetland crossing along the ROW access road where turbid water has overtopped the silt fence. This is the most water we have seen in this area since the project began. Photo on the right is an overview of the access road leading to the 2nd crossing. 1/19/05

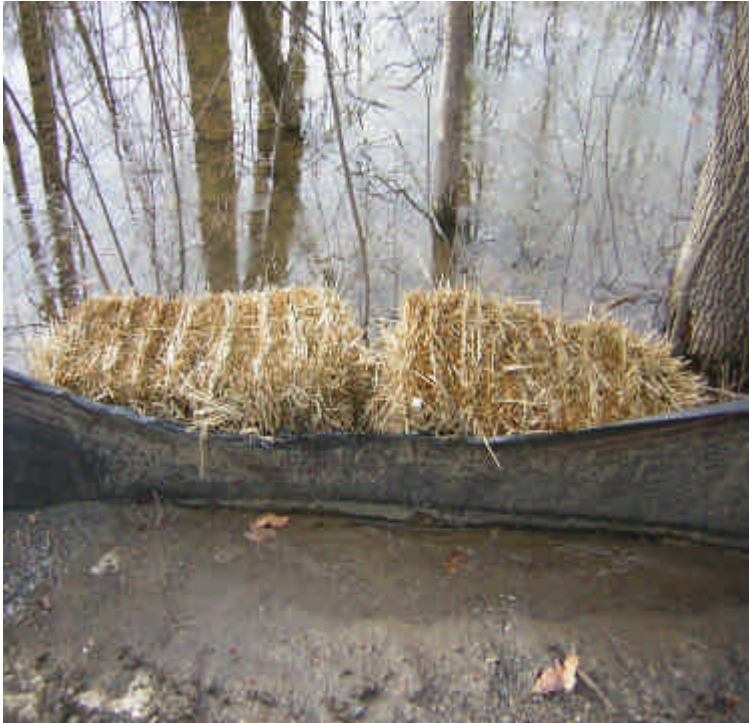
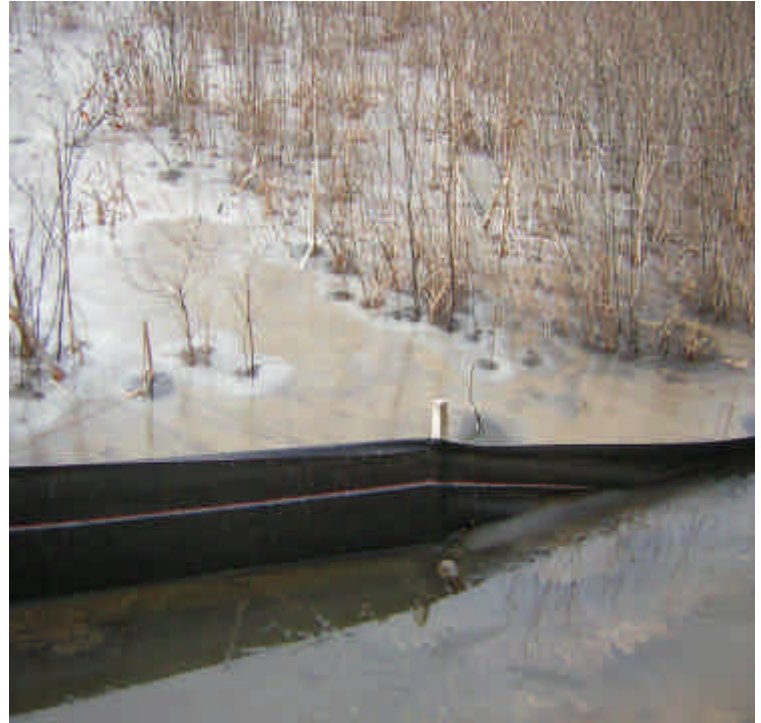
Photo on the left shows some of the controls in place at the 1st wetland crossing along the access road from Archers Lane. Photo on the right shows turbid water in the wetland at the 2nd crossing. Controls were overwhelmed by the amount of water and turbidity was resulting. 1/19/06

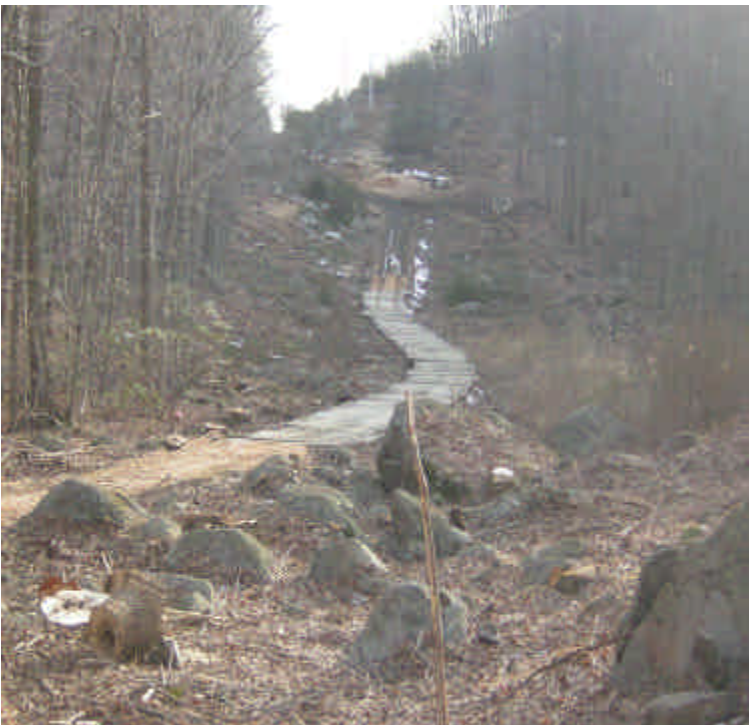
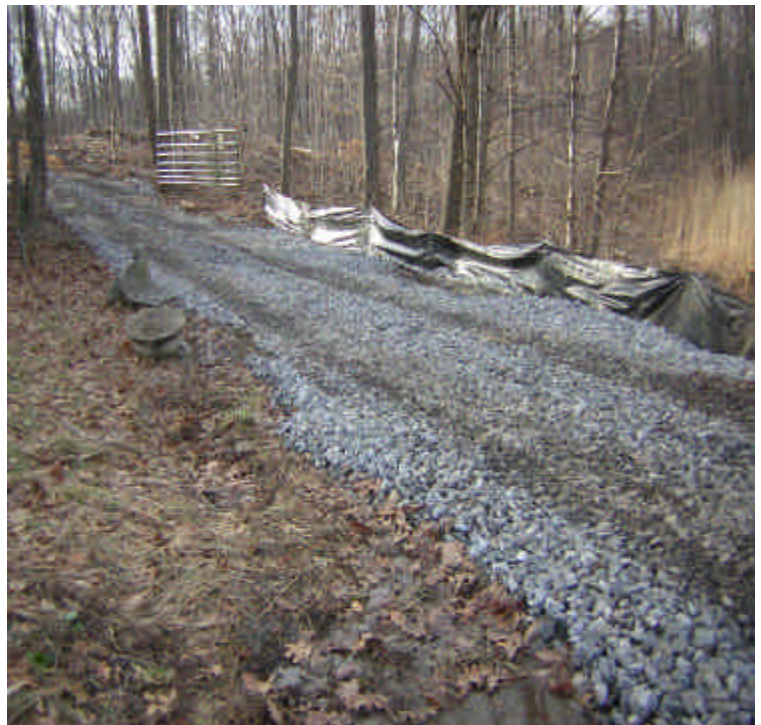
345kV (H-Frame Section): Photo on the left shows where mats were installed at the larger wetland crossing near the Bethel Reservoir land. Photo on the right shows the stone and silt fence installed on the access road into the ROW. 1/19/06

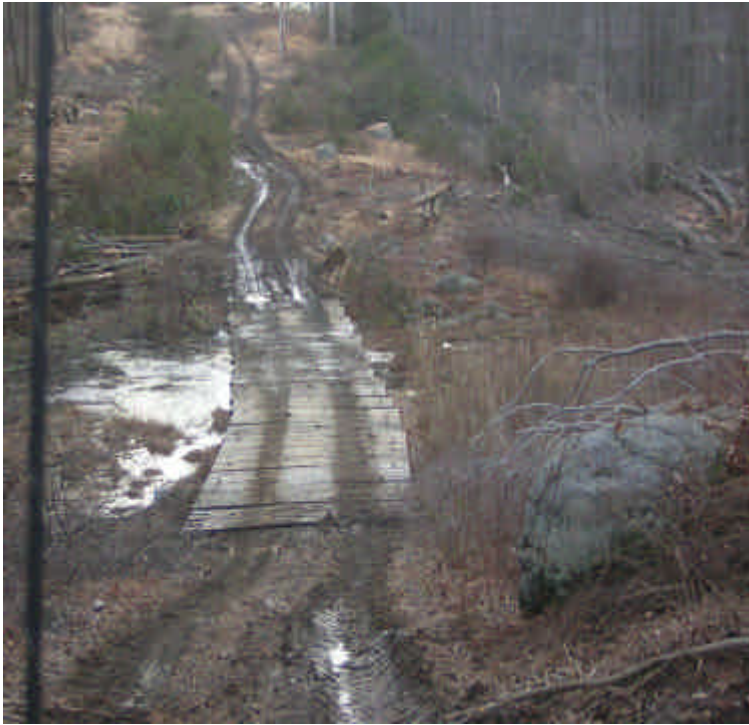
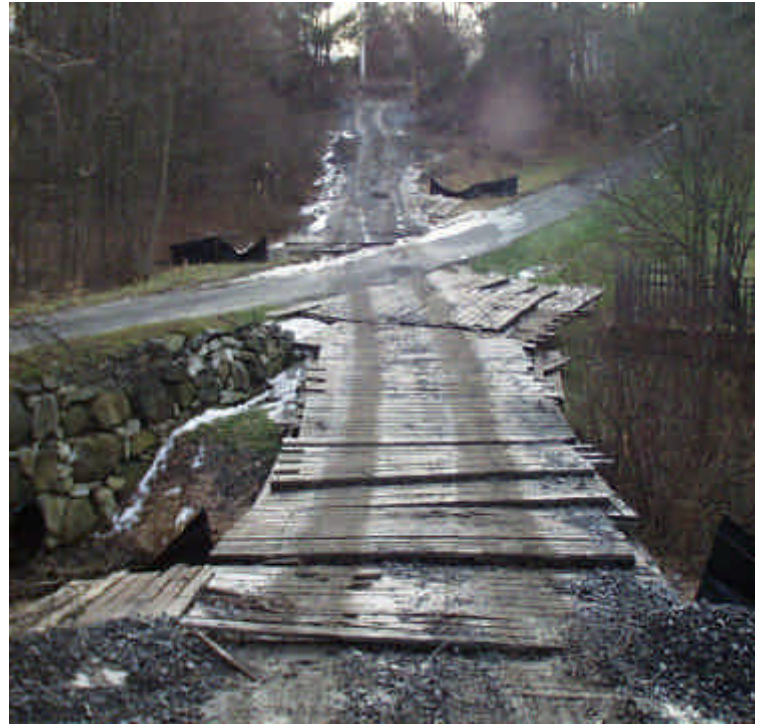
Photo on the left shows a wetland crossing with mats well installed along the Bethel res. Portion of the ROW. Watch sediment issues and install erosion controls on the approach to the wetland. Photo on the right shows the stream and wetland crossing of Chestnut Ridge Rd. with mats well installed. 1/19/06

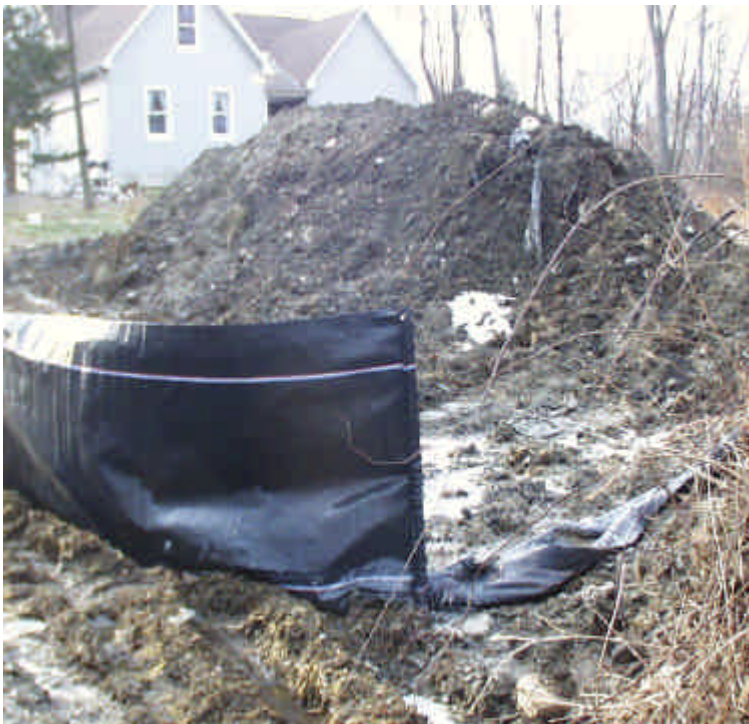
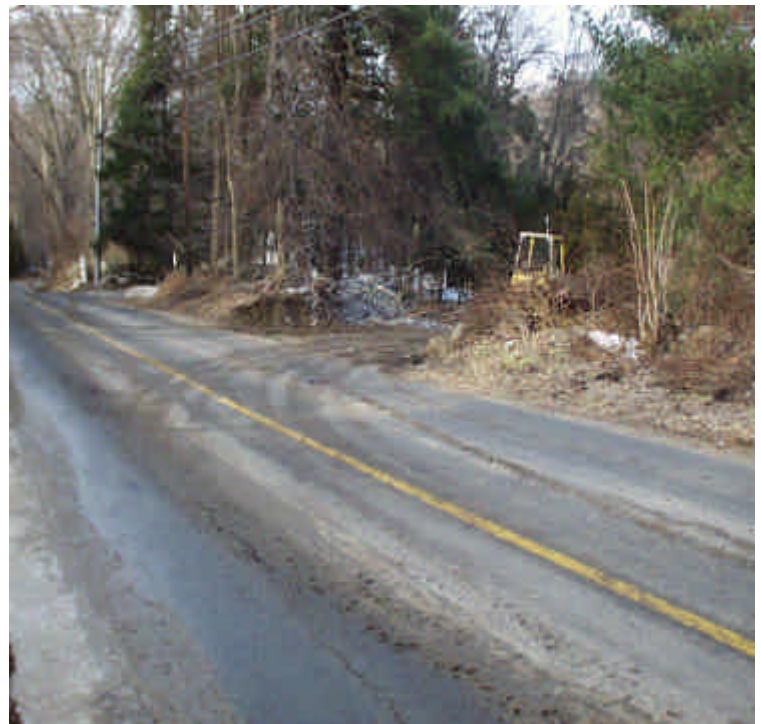
Photo on the left is a view of the stockpile remaining at Chestnut Ridge Rd. Silt fence needs repair and turbid water was running down the driveway. Sediment tracking was also noted out into the roadway and additional stone should be installed at the access points. 1/19/06

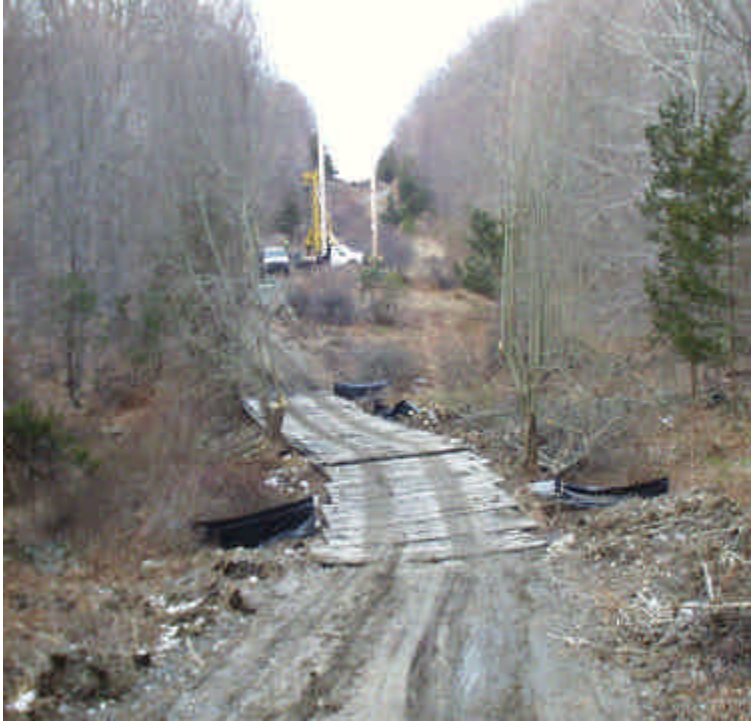
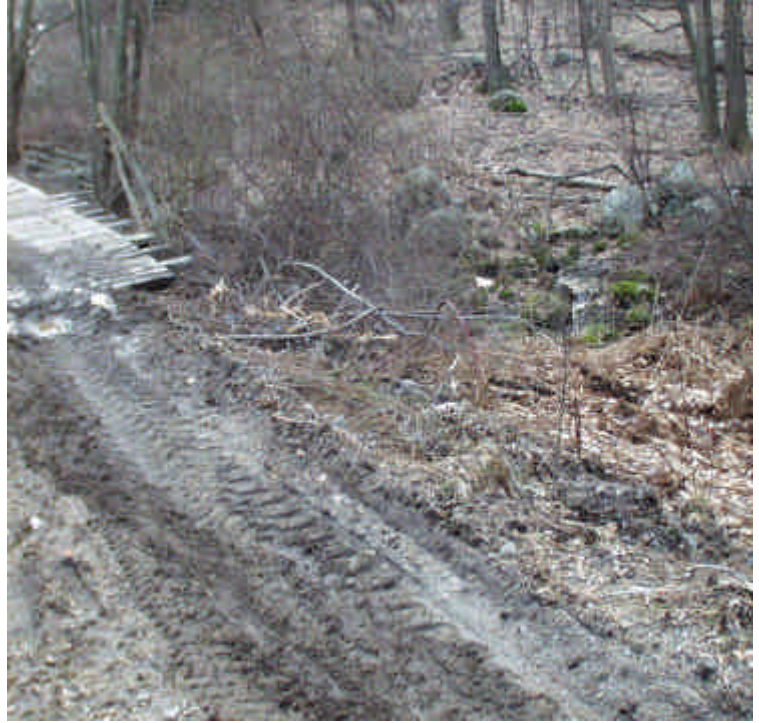
Photo on the left is a view of a wetland crossing between proposed structures #6 and #7. Mats are well installed and some areas of silt fence were installed as recommended. Make sure controls extend to the edge of the mat. Photo on the right shows one corner where controls were not installed. 1/19/06

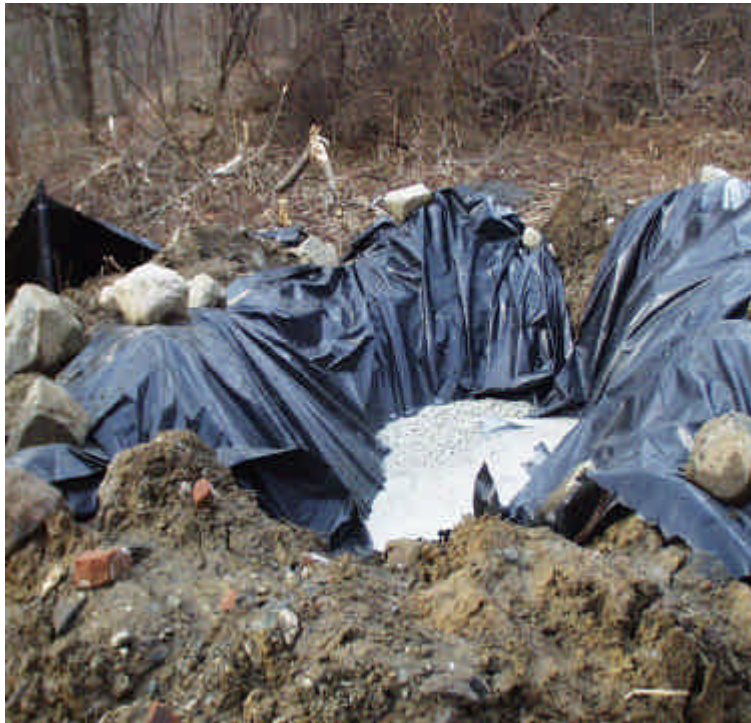
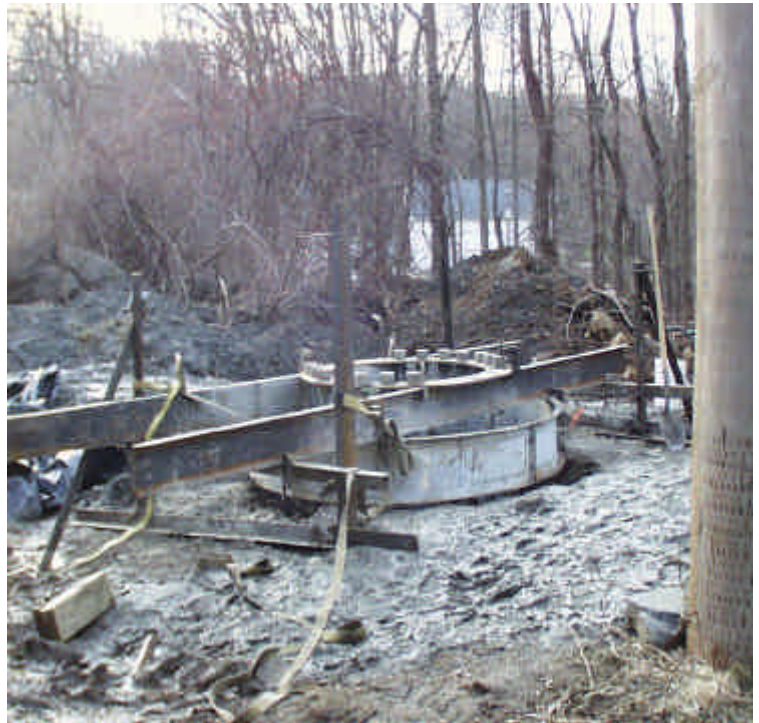
Photo on the left is a view of a concrete washout area. Trucks were observed using this lined area. Photo on the right shows the foundation installation at proposed structure #8. Stockpiles in the background of the photo need some erosion controls if they are to remain. 1/19/06

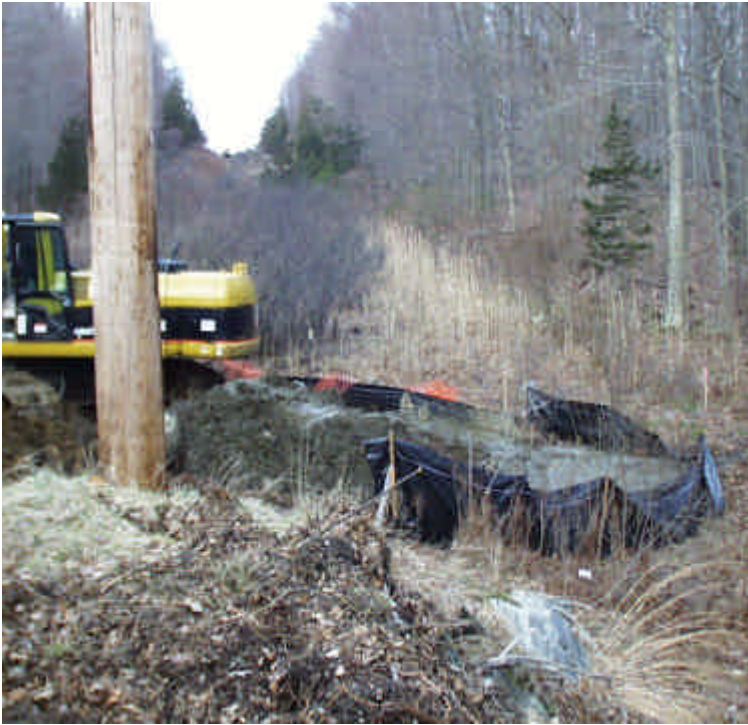
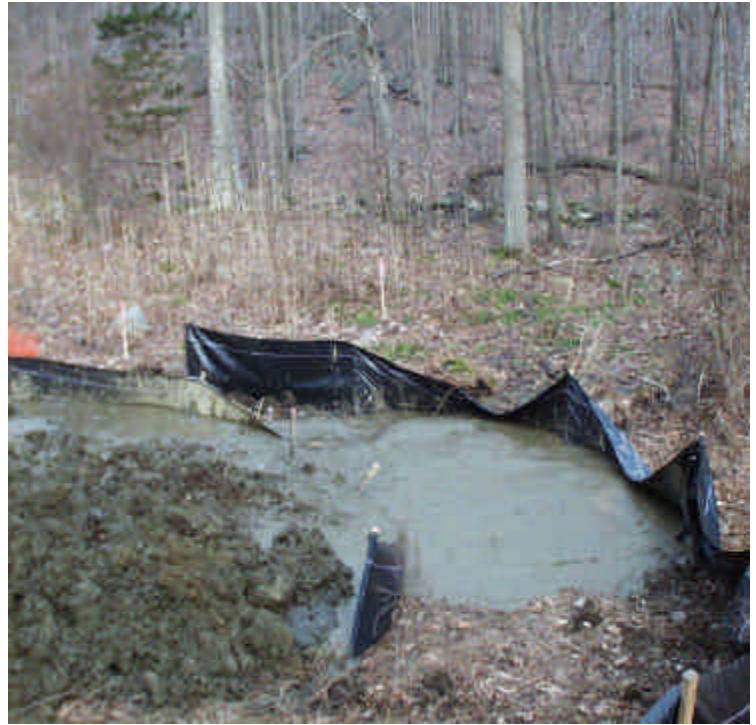
Photo on the left is a view of the excavation for proposed structure #6. Additional silt fence was added when the first fence was overwhelmed. Photo on the right shows a closer view of the mud against the final fence. While the fence is keeping a majority of the mud contained, this area is a wetland and the mud will have to be pulled back and removed. 1/19/06

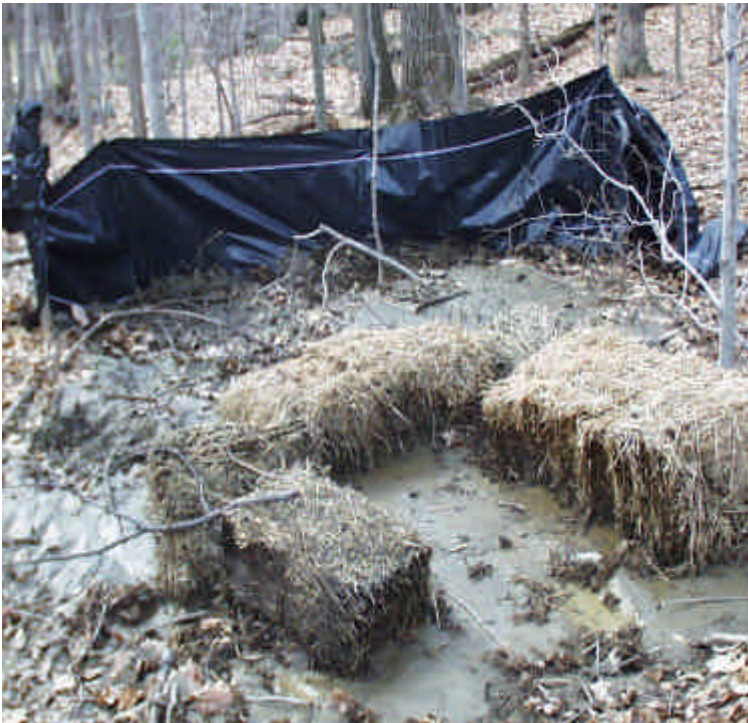
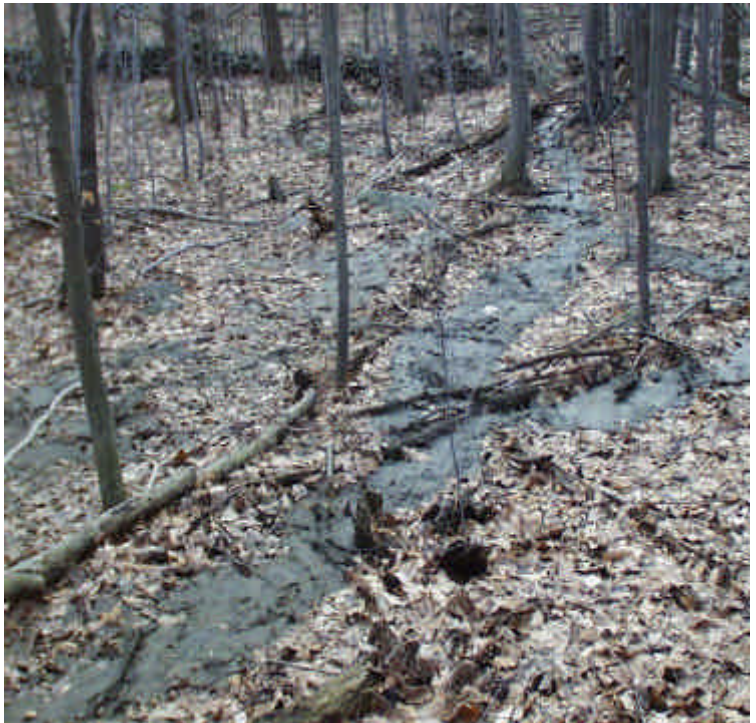
Photo on the left is a view of the attempt to contain dewatering from proposed structure #6. The area was not sized for the amount of sediment it received. Photo on the right shows the sediment trailing down through the woods to the edge of a wetland at the base of slope. 1/19/06
